ISSN:1306-3111
e-Journal of New World Sciences Academy
2007, Volume: 2, Number: 1
Article Number: A0015

Kamuran Öztekin
Salih Taner Yıldırım
University of Kocaeli
koztekin@kou.edu.tr
Kocaeli-Turkey

BUILDING, CONSTRUCTED REGIONS AND THE EARTHQUAKE IN KOCAELI

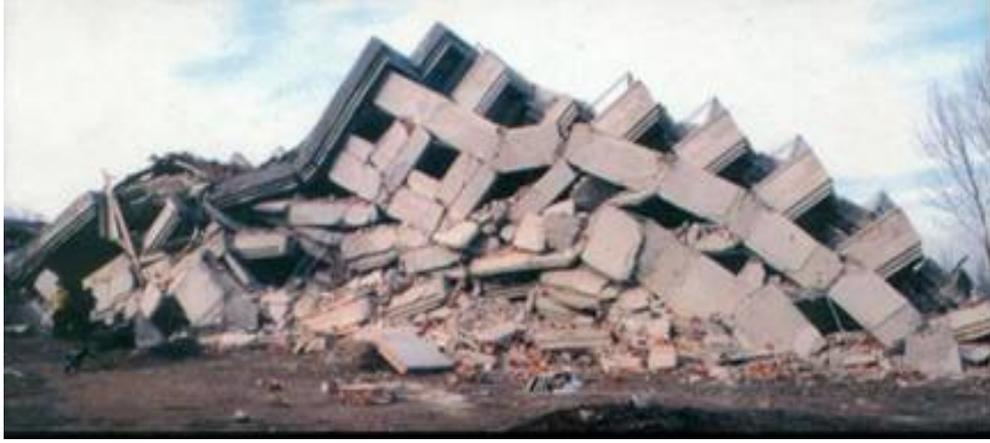
Apartment house types built with reinforced concrete framework system which collapsed in Kocaeli Earthquake were exposed to collective collapse on a large scale [12 and 13](Picture 1). The reasons for the damage on types of houses collapsed or damaged are given below:

Picture 1. A reinforced concrete framework apartment house collapsed in the earthquake in Kocaeli [12]
(Resim 1. Kocaeli'deki depremde yıkılan betonarme karkas bir apartman)

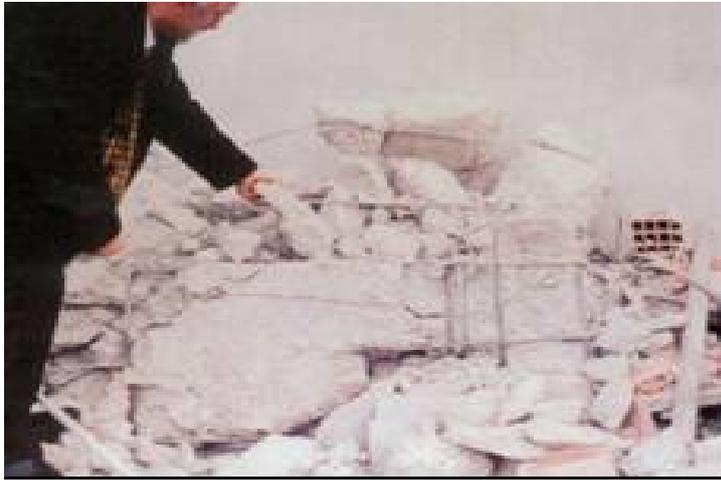
Picture 2. Problems relating to the poor quality of materials
(Resim 2. Malzeme kalitesizliği ile ilgili sorunlar)

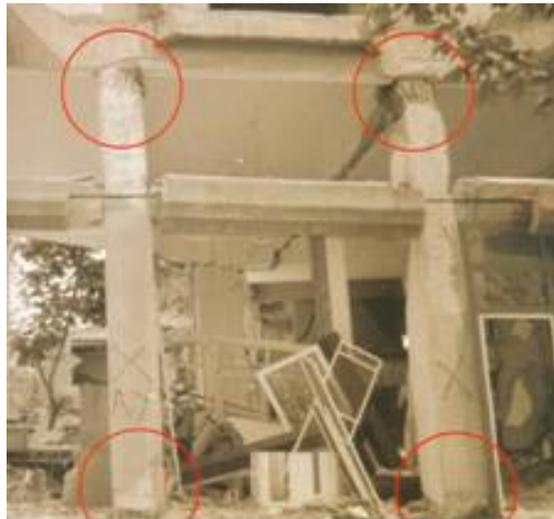
Picture 3. Problems at the points of connection of beam end and a column
(Resim 3. Kolon-kiriş birleşim noktalarında problemler)

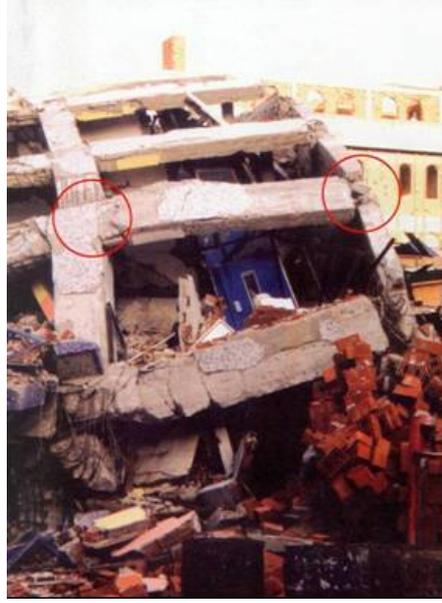
Picture 4. Column-beam connection problems
(Resim 4. Kolon-kiriş bağlantı problemleri)

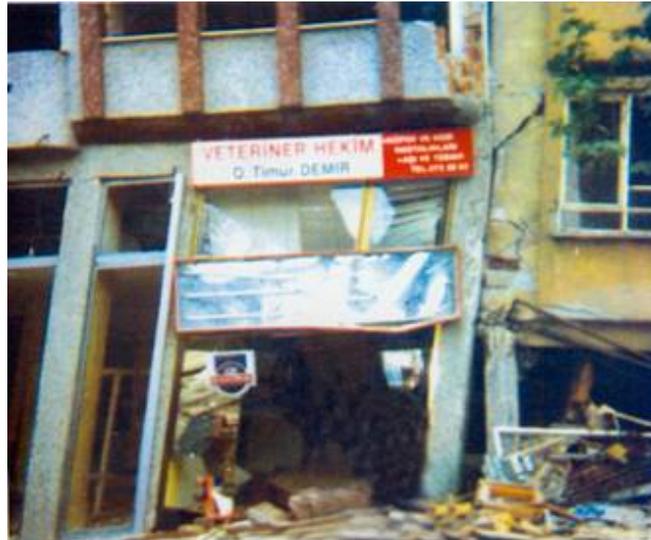
- Opening up the ground floors for commercial use (Picture 5)[12],
- Providing reinforcement for buildings that were damaged in early earthquakes [14, 15 and 16].

Picture 5. Soft storey problems
(Resim 5. Yumuşak kat sorunları)
